Interlude - Oil Filter Failure

We had a bit of a near miss on Interlude today.

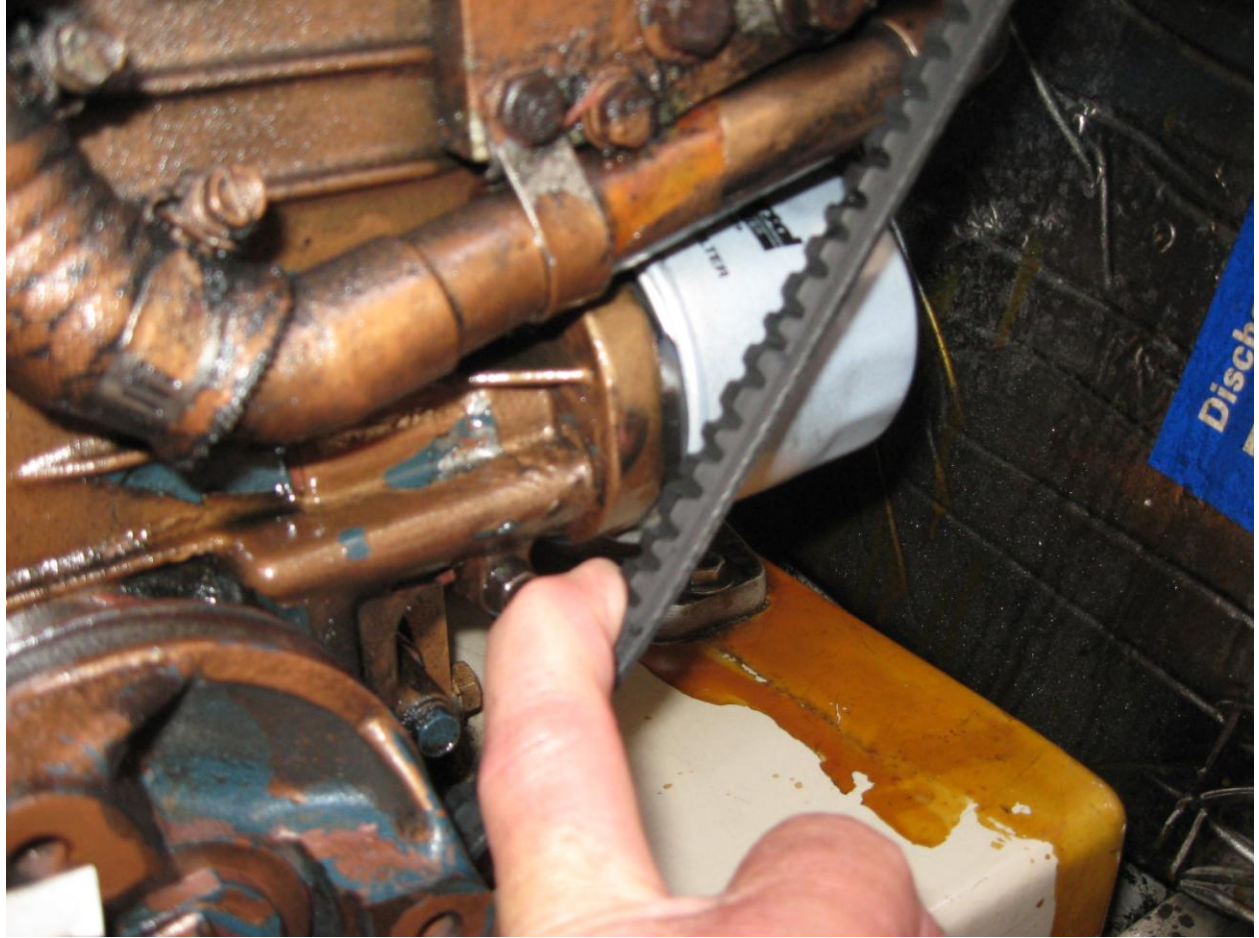
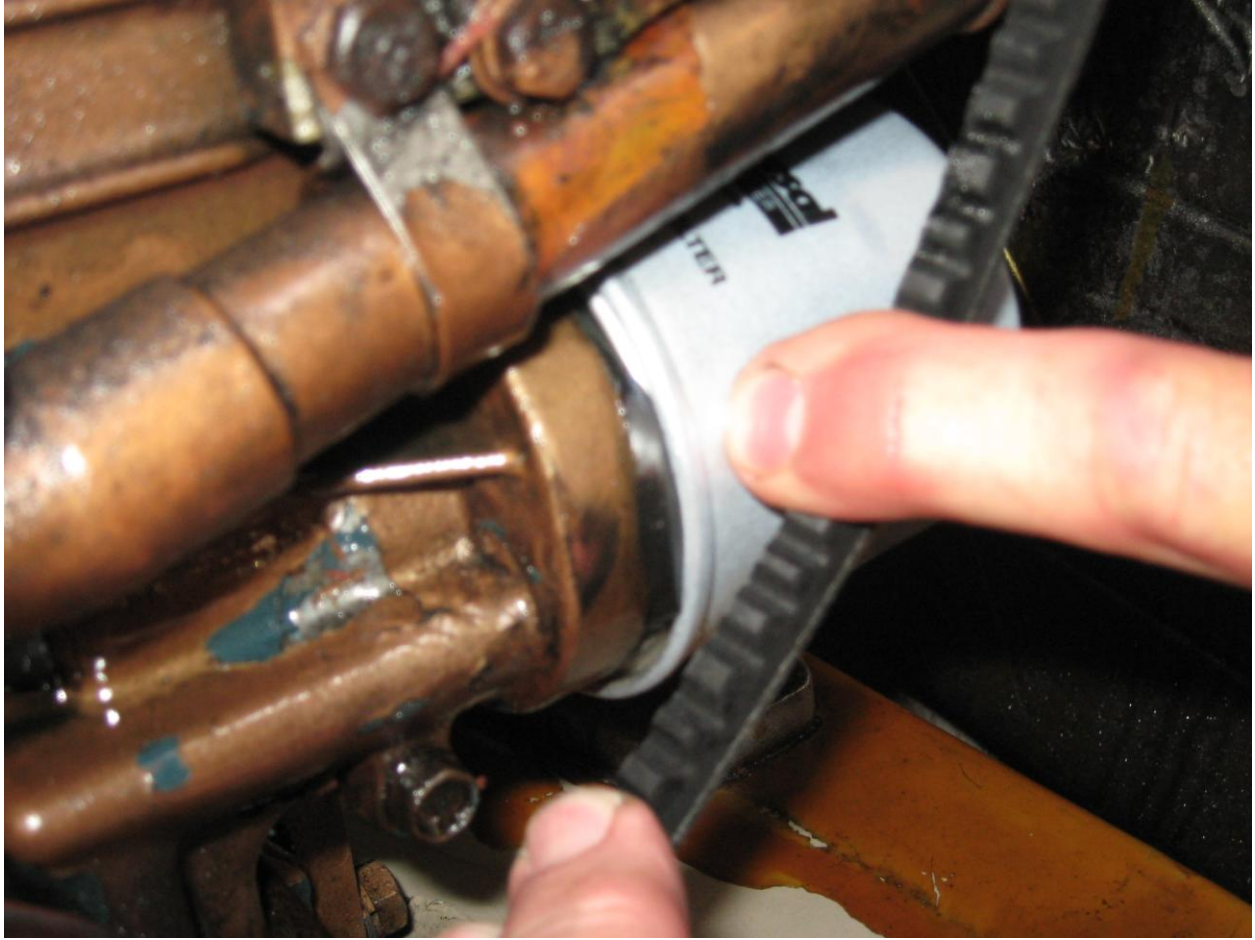
Blame - *This was not the fault of anyone in ASI doing an oil change.* This is the first time I have seen a gasket failure of this type so I checked the filter gasket. On every filter I have seen the gasket is a hard but malleable rubber that is held in place by the metal body crimped against the rubber ring - and it may also be adhered to the metal body in some additional way. As you can see from the pictures the rubber gasket, due to the internal pressures of 60 psi had blown out of the engine facing seal area, allowing the leak. The rubber was also soft to the touch and it easily came away from the filter body. This problem was due to a manufactures defect - rare - but anything can happen. The blame lays with the product not the installer, and no I didn't change the oil and filter on the Interlude.

See included two pictures below of Interlude's oil filter on engine, note the rubber seal:

What I learned from this - typically I clean the engine mating surface, then put a little clean oil on the filter gasket before screwing the filter into place and then I hand tighten. From now on I will inspect the rubber gasket and make sure it is firmly in place and it shows no visible defects before I put it on the engine, something I used to take for granted. I will also add a visual inspection of the filter/gasket area on my pre-sail engine check/inspection. Maybe feel around the seal area for a bulge of rubber. I may never see this type of failure again but I will never forget it either.
